# Failure analysis of broken turbo wheel flange

J. Bendayan

Dayanson Shaked Ltd, Caesarea, Israel  
E-mail: shaked00@013net.net

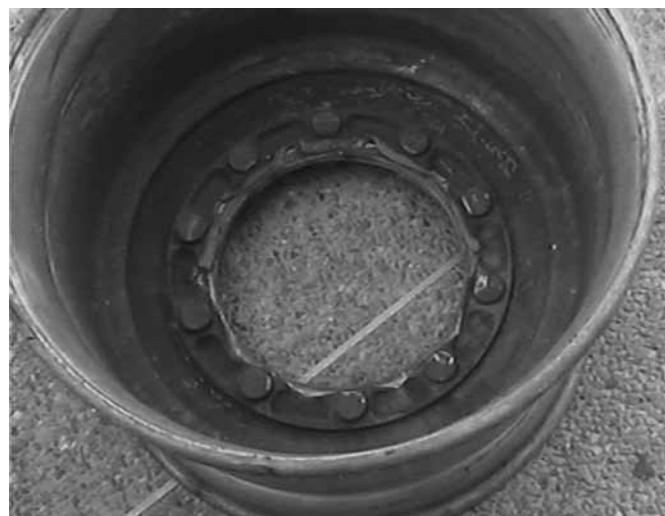
The wheel with the broken off crown of the flange is shown in Fig. 1. The central part of the flange is shown in Fig. 2. The flange crown consists of 10 lugs with the holes for fastening the flange to the wheel. All lugs broke off at their base.

Figure 1. View of the wheel with broken off flange crown.

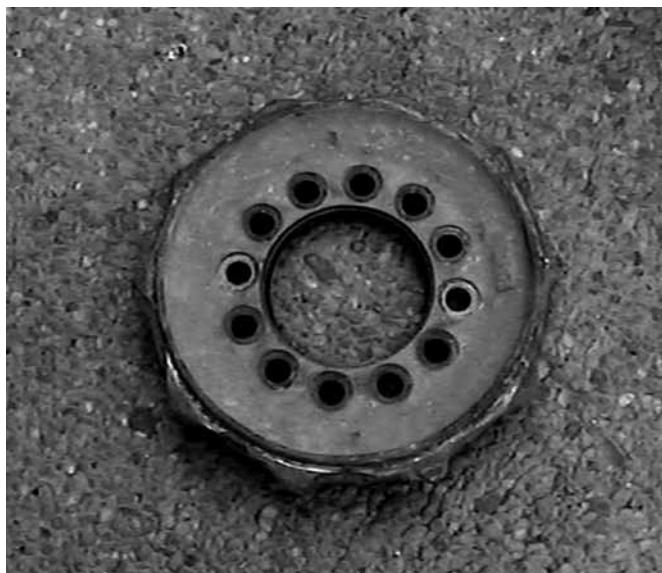
Figure 2. View of the failed flange – the crown is broken off.

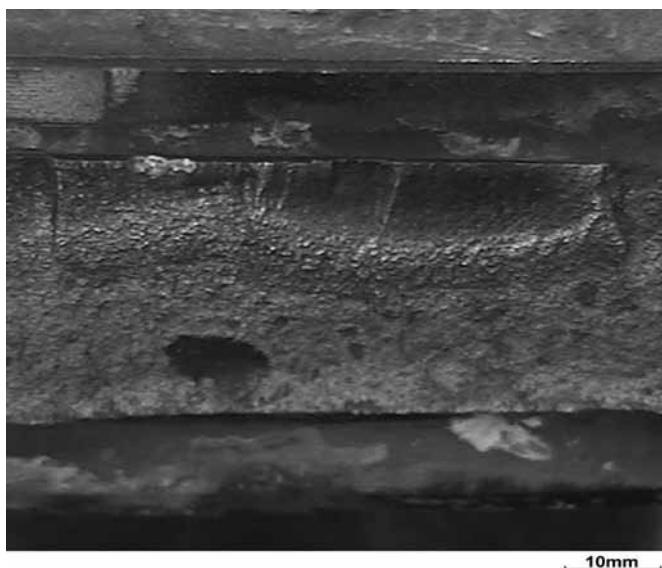
The typical fracture surface of the lug is shown in Fig. 3. It is characteristic of fatigue fracture initiated at one of the sides and propagated till about a half of the lug thickness up to the final fracture.

Figure 3. Close-up of the fracture surface of the flange.

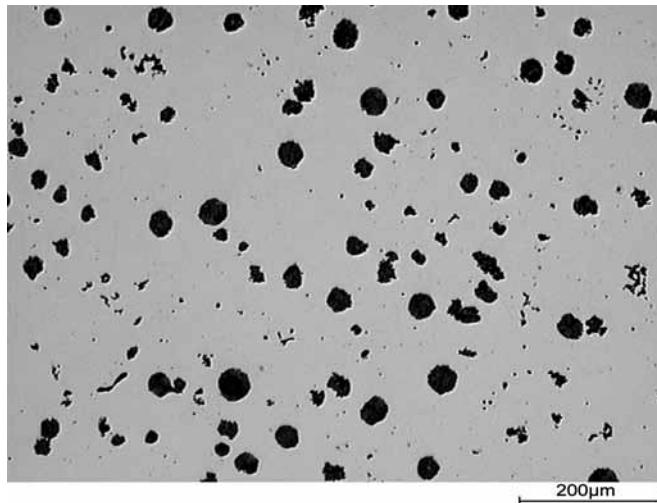
optical microscope. The spheroidal graphite of type I according to SAE J434 was found (Fig. 4). After etching in Nital 2% the microstructure metallic matrix consisting of ferrite and pearlite

Figure 4. Nodular graphite form of the flange material.

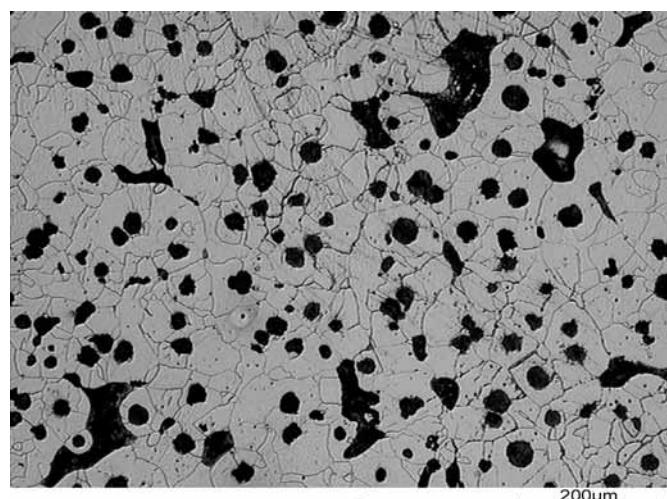
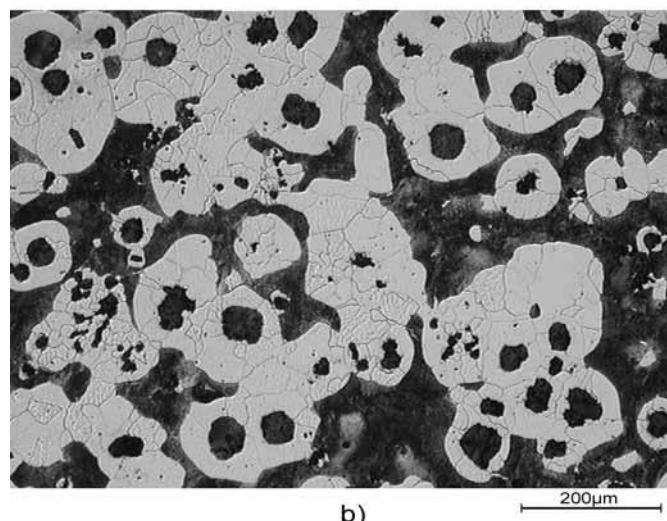
was revealed (Fig. 5a, 5b). As can be seen from these photographs the pearlite content varies from about 10 to 40%. The graphite form and the microstructure of the metallic matrix correspond to the ductile cast iron SAE J434 Grade 4512 to Grade 5506.

Figure 5. Ferritic-pearlitic microstructure of the metallic matrix:  
a – 10% pearlite content, b – 40% pearlite content.

- The microstructure of the metallic matrix is not uniform: the pearlite content varies from 10% to 40%. The areas with decreased pearlite content have decreased local strength, which manifest itself in decreased fatigue strength.
- The failure of turbo wheel flange is a result of fatigue crack initiation and propagation. The lifetime of the product was reached.

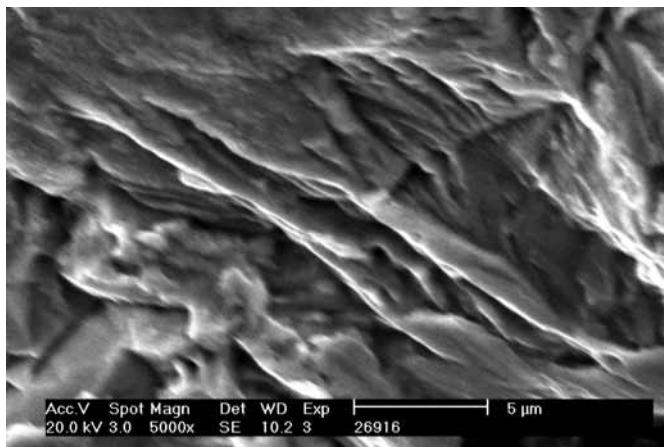
The morphology of the fracture surface was examined using a Philips XL30 scanning electron microscope (SEM). The fatigue striations found in the fatigue zone of the fracture surface are shown in Fig. 6. The morphology of the fracture surface in the final fracture zone consists of large shallow

Figure 6. Fatigue striations found in the fatigue zone of the flange fracture surface.

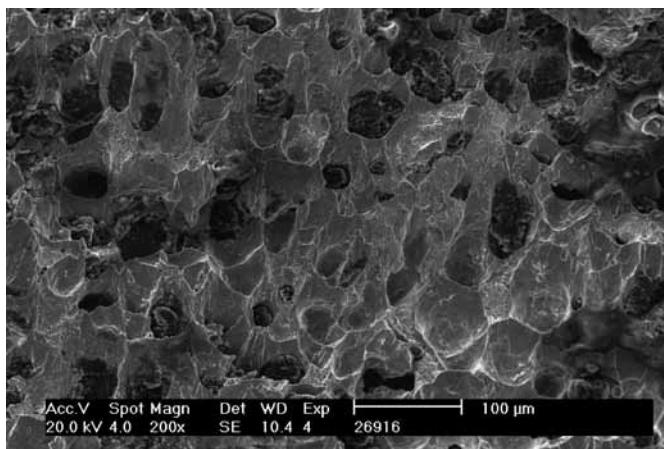
dimples formed from graphite spheroids (Fig. 7). At higher magnification small dimples were also found (Fig. 8). This morphology is characteristic of final fracture of the ductile material [3].

Figure 7. Final fracture zone at low magnification.

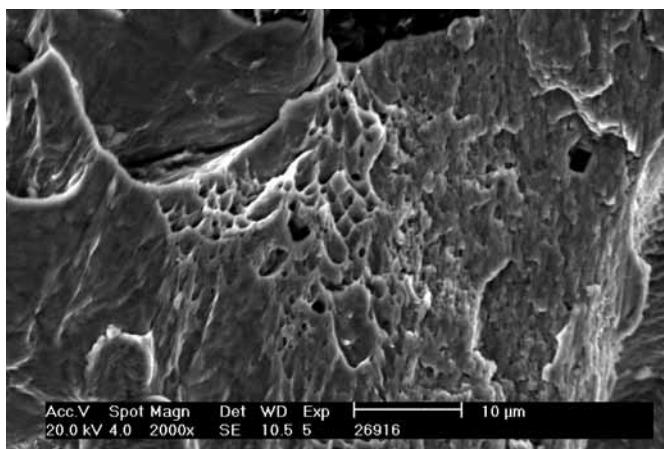
Figure 8. Final fracture zone at high magnification.
