Reparation, inspection and damage analysis of steam boiler

M. Arandelović, N. Milovanović, B. Đorđević, S. Sedmak, I. Martić

Innovation center of Faculty of Mechanical Engineering, University Belgrade, Serbia

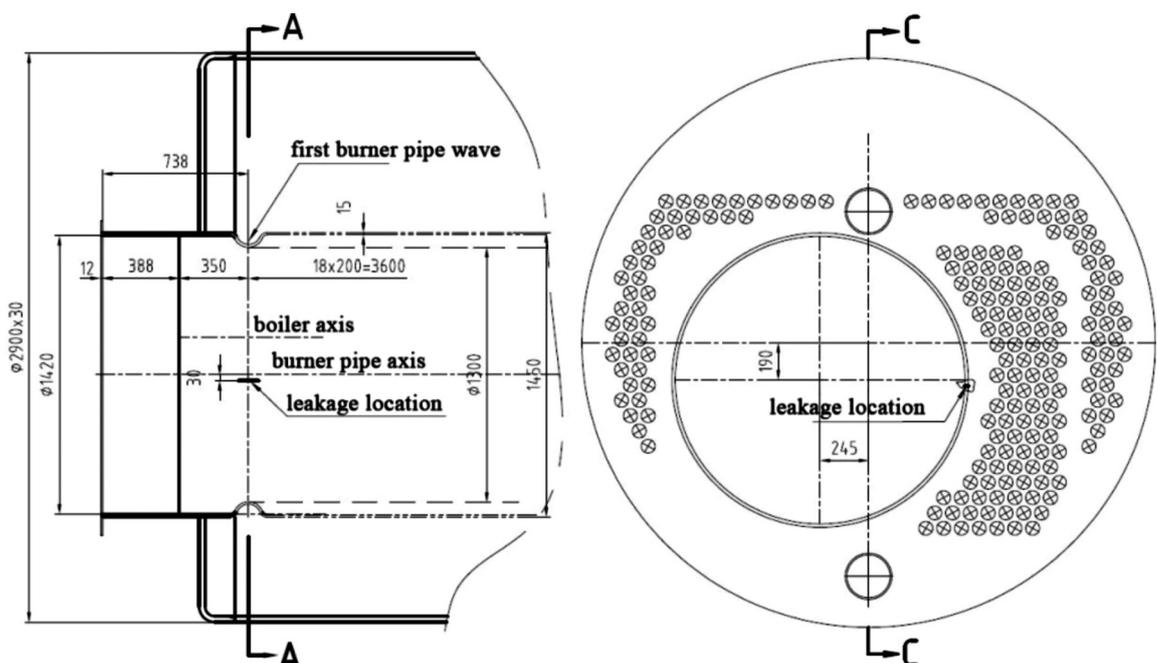
Leakage was observed in boiler (fabric number 5473) wave furnace tube (Fig. 1). It was noticed by maintenance staff and the other pipe layer was disassembled to find the exact place where leakage occurred. It happened at the burner pipe, nearest to the boiler, some 100 mm from back side of boiler and some 30 mm from burner pipe axis. Crack was longitudinal and its propagation was across the whole thickness of burner pipe (Fig. 2), and by it was concluded by the Notified body that

Figure 1. Schematic of boiler wave burner pipe and leakage location.

reparation was needed, by welding without changing the base material. Welding process was done in accordance with adequate welding technology and that will be explained latter in more detail. Before reparation, visual inspection was done in scope of 100%. Also penetrate testing was done to find beginning and end of crack propagation.

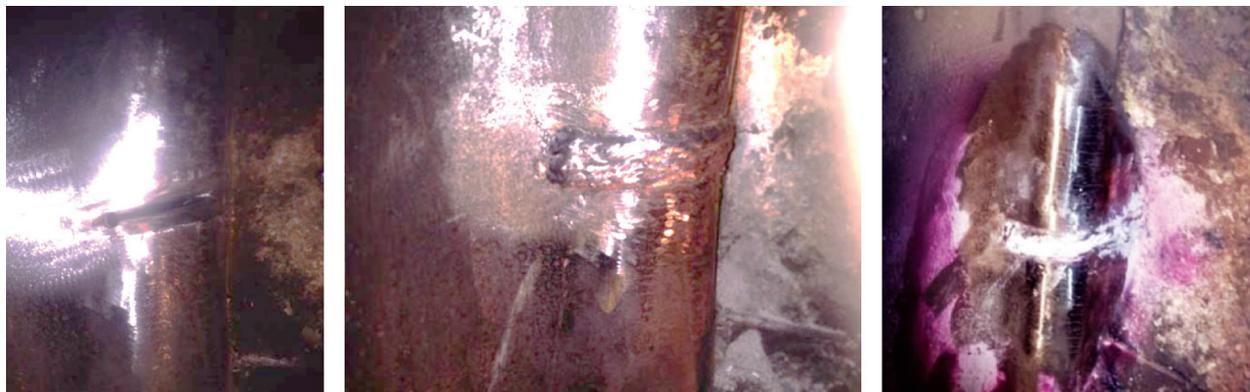
Figure 2. Cracks across the whole thickness of wave furnace tube.

It is assumed that failure happened in base material of a tube where defects occurred during material production or casting. The reasoning behind this conclusion was that usually this type of failure during exploitation is not that common in wave pipe burners.

Groove preparation was performed for the purpose of cracks repairing by grinding and the groove making until it is clean and

should be done using grinding tools with controlled heat input (boring should be done with interruptions to prevent material overheating). Prepared groove surface was ground until it was smooth and clean with sloped sides and root fillet with $R = 8$ mm.

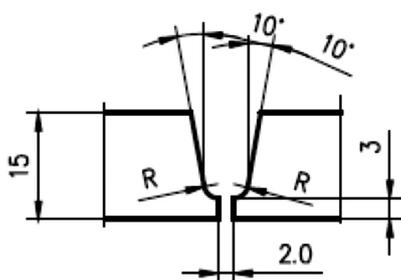
Due to the lack of ultrasound control for the purpose of determining crack depth, the real state was only possible to detect after they were removed. Gradual removal of cracks during the forming of the groove, it was concluded they are spread along the whole length of the flame pipe. Based on the type of detected cracks, the groove was prepared for welding according to Figure 3. Prior to this, every free end of the crack was bored using 5 and 8 mm drills. Groove preparation

Figure 3. Preparation of grooves for welding.

the existing cracks were completely removed.

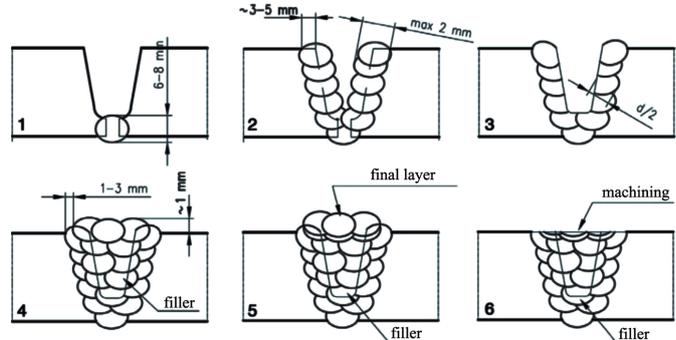
Figure 4. Exact way how welding procedures were done.

Weld root was done in two passes, using the electrode tip dragging technique. Root weld height should be 6-8 mm. Groove slopes, including the edge zones, should be welded during the first pass, with multiple layers, along the whole surface, using a 2.5 mm electrode. Every subsequent layer should be laid out so

that it overlaps with the previous one up to one third of its width. This ensures the annealing of the base material. Overlapping must be within the range 1-3 mm. Final layer is completely covered, hence stress annealing of all previous layers was fully achieved in this case (Figure 4).

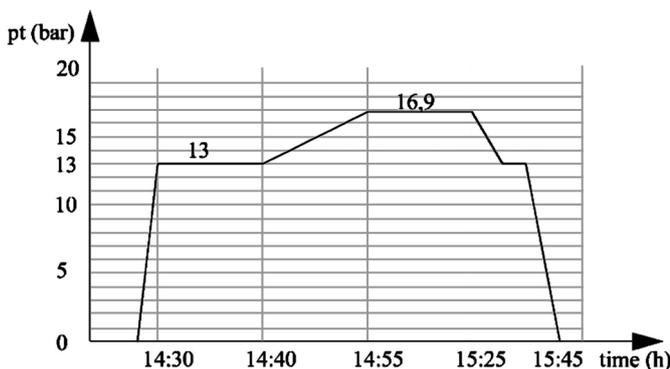
Next testing that was performed on wave furnace tube was pressure test (test fluid was water) with 16.9 bar (Fig. 5). Pressure was gradually raised (4 bar/minute) until pressure in pipe reached the work value of 13 bar, and that pressure was maintained for

some 10 minutes and in next 15 minutes pressure was raised to test pressure of 16.9 bar. Test pressure was maintained for 30 minutes, and after that period of time, slowly started to drop for next 10 minutes to work pressure of 13 bar. In this moment, inspection was performed along with leakage test to see if there is leakage in the welded joint. During this

test, no defects were detected, as was case with surface testing. After testing was done, test fluid was released from tube over a time interval of 5 minutes.

Figure 5. Plan of hydro-testing.
