# Chemical, structural, mechanical and corrosion characterization of the extraction pipes of natural gas

D. R. Pascu<sup>1</sup>, R. Roşu<sup>1</sup>, V. Deac<sup>2</sup>

<sup>1</sup> National R&D Institute for Welding and Material Testing - ISIM Timișoara

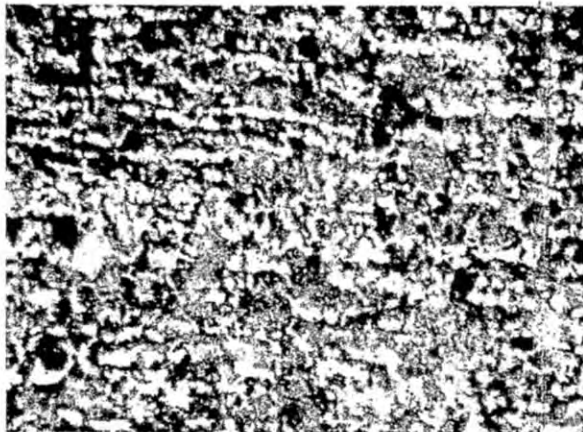
- At sample M1, pearlite-ferritic microstructure with the grain score of 7-8 according to ISO 643: 2003, the pearlite percent does not exceed 42% (Figure 2);

Figure 2. Sample M1, BM, [Etched Nital 2%, 100x]

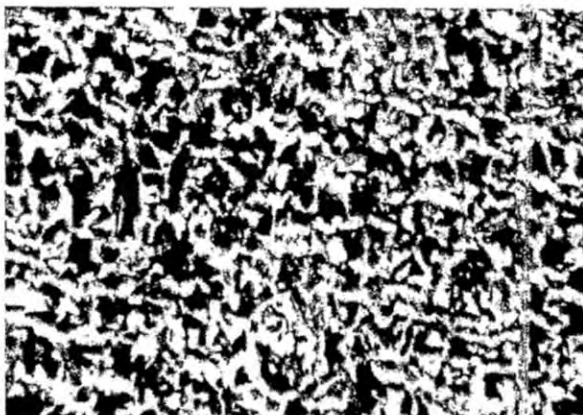
Figure 4. Sample M4, BM [Etched Nital 2%, 100x]

- The sample M4 presents pearlite-ferritic microstructures with the grain scores between 6 and 8 according to ISO 643: 2003 the pearlite percent is 35% (Figure 4).

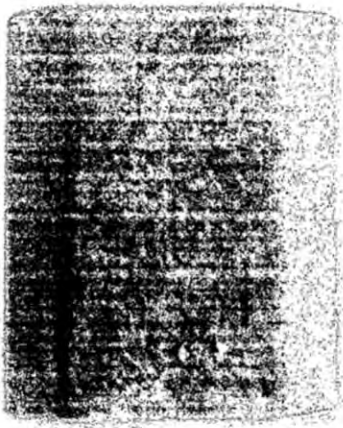
Flattening tests according to SR EN ISO 8492: 2005, were made on samples taken from the pipe of 100 mm. All the tested samples showed lateral cracks at plastic in compression test machine (Figure 13÷16).

Figure 13. Flattening sample 1

The presence of cracks on the side surfaces of the flattened pipes show a low capacity of the non-alloy steel to compression deformation.

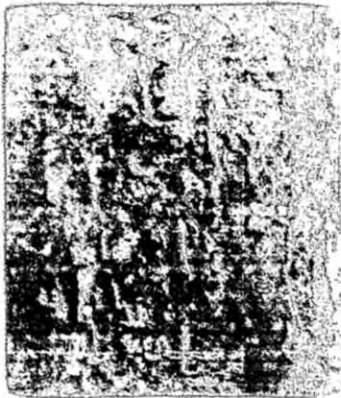
Figure 14. Flattening sample 2

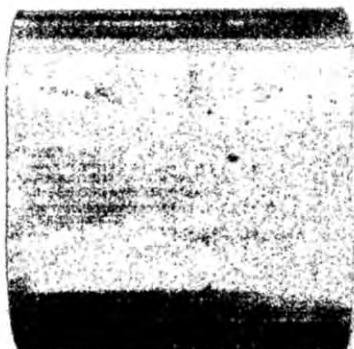
Figure 15. Flattening sample 6
