Re-use of an existing steel structure as part of sustainable development

2. Re-use of an crane – girder for a footpath bridge

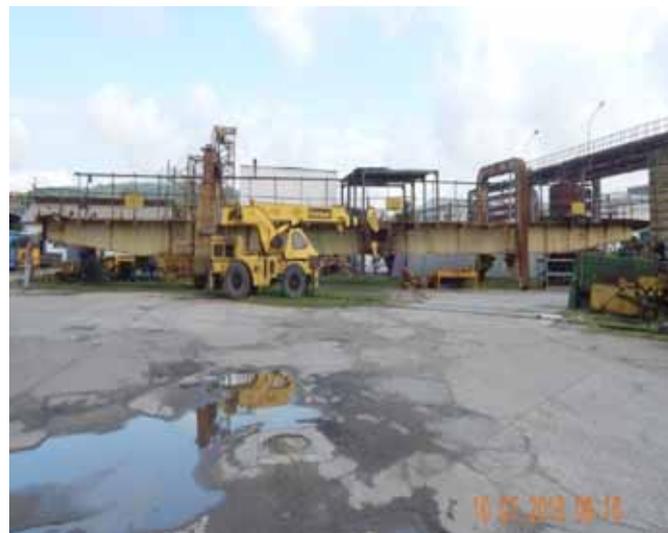
An example in this direction refers to a former disaffected portal crane girder. An existing portal crane constructed in 1979 was disaffected, in an enterprise in the town of Bistrița

(Fig. 2). The characteristics of the crane are: $Q_{\max} = 20/5$ Tones and $D=20+2 \times 6$ m. The main girders have a box girder cross section, with $b=650$ mm and $h=1300$ mm in the field, respectively 700 mm on the bearings. The web is 8 mm thick supporting the crane rail. Statically it is a cantilever girder with $L=6.00 + 20.0 + 6.00$ m. Both main girders situated at a distance of $B=4208$ mm, are connected at the end with two cross girders. The technical condition of the structure is rather good (Fig. 3); a relative recent general control made by “ISCIR - National Authority for Control and Approval of Boilers Pressure Vessels and Hoisting Equipment” is positive. Even the thickness of the elements corresponds to the initial values from the project. The welds were verified by the magnetic particle inspection; the result was satisfactory.

Figure 2. The disaffected crane.

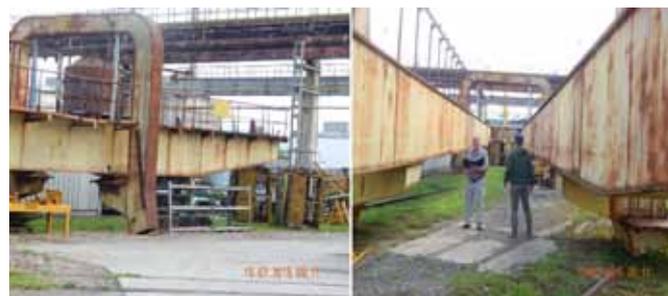
Figure 3. General view of the crane girders.

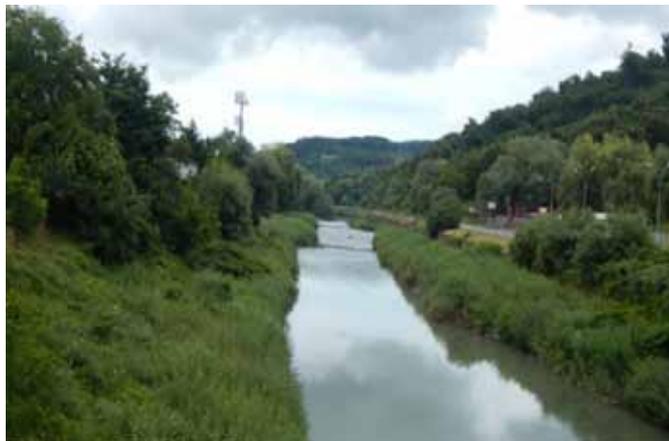
The footbridge will be placed in the center of the Bistrița town realizing the access of the pedestrians and cyclists to a picturesque recreation area (Figure 6).

Figure 6. Location of the future pedestrian bridge.

The steel girders were proposed for a pedestrian bridge, in the middle of the town of Bistrița connecting the two parts of

a natural park very appreciated by the inhabitants (Fig. 6). The first step was the assessment of the structure; it was performed in accordance with the European Standards [4] and the standards available on the time of the crane construction:
